Project: I-64 Hampton Roads Bridge-Tunnel Expansion
Meeting Title: Monthly Environmental Agency Meeting
Date: June 28, 2019
Location: DoubleTree Inn, Norfolk VA.
 1500 N. Military Highway, Norfolk VA 23502

Environmental Agency Meeting
28 June 2019

I-64 Hampton Roads Bridge-Tunnel (HRBT) Expansion Project

JPA Pre-Application Meeting
10 July 2019

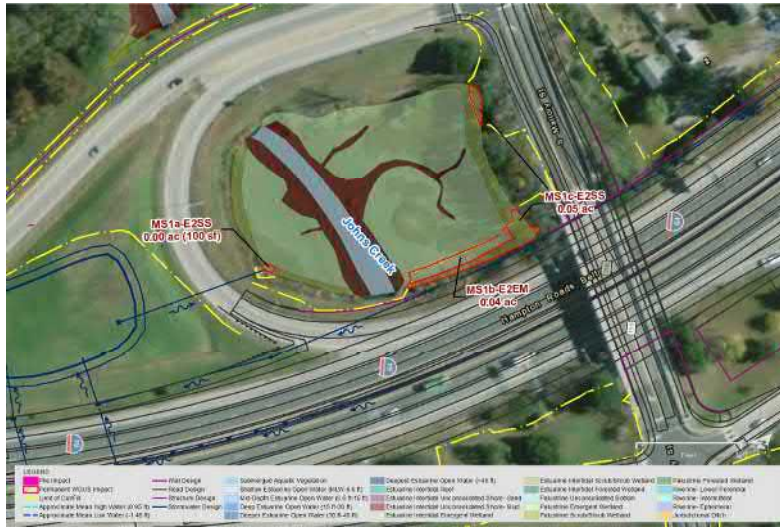
Mallory Street

Impacts

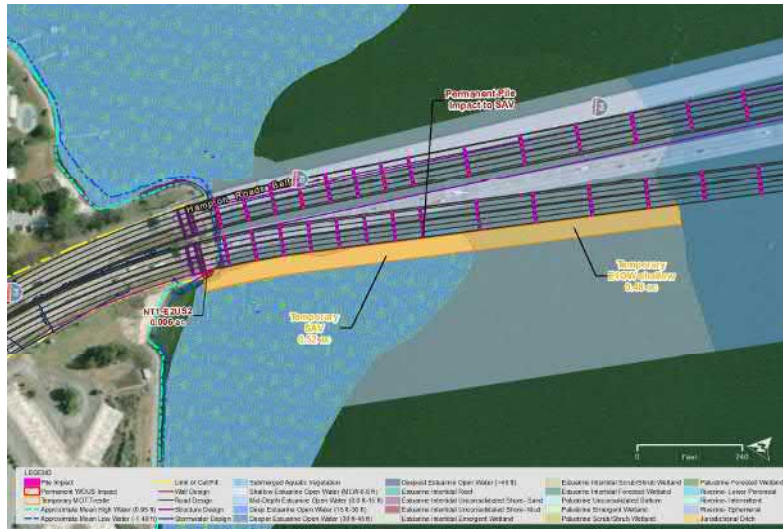
North Trestle

Temporary Extended Impacts

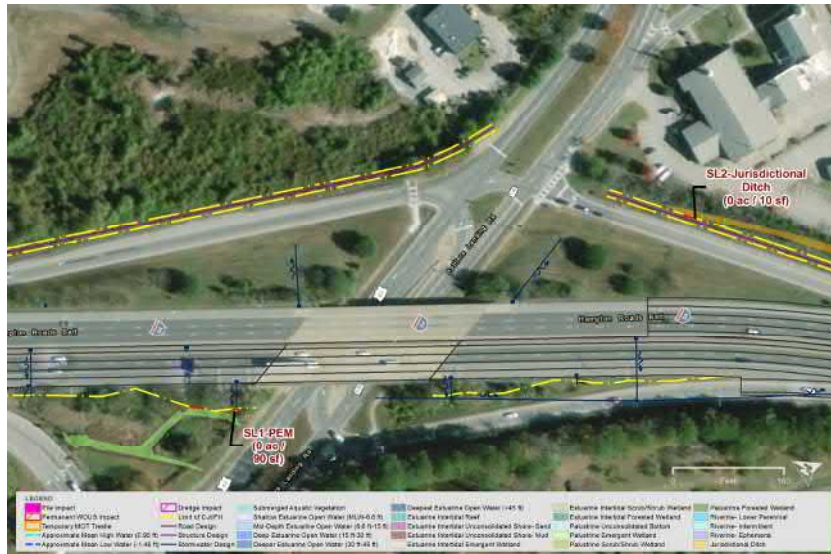
■ Permanent Impacts - Settlers Landing

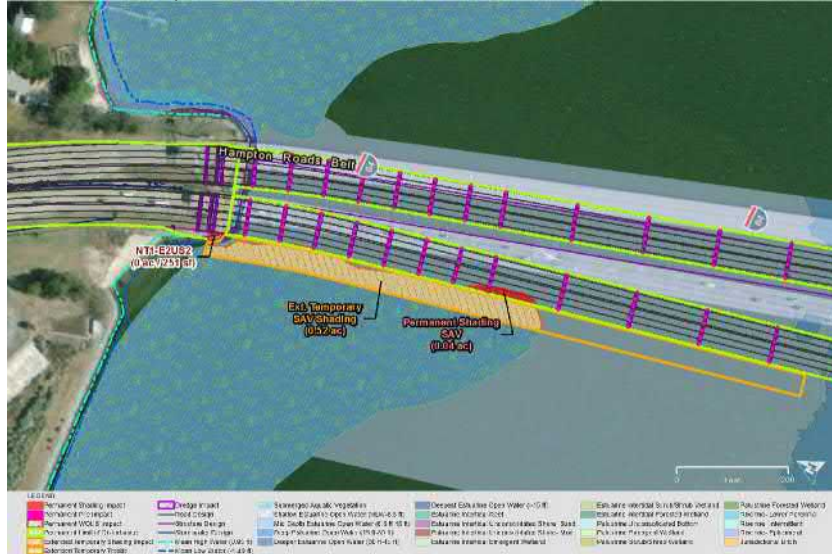
■ Permanent Impacts - North Trestle

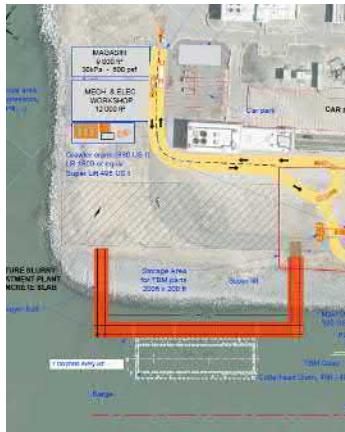
Extended Temporary Impacts (>12 Months)

- South Island TBM/Supply Platform
- Conveyor – TBM Spoil Movement

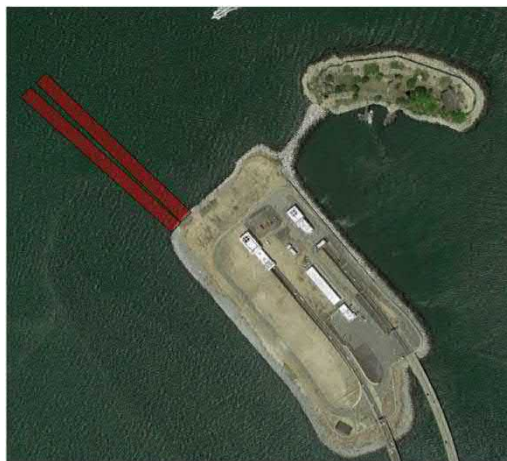
Extended Temporary Impacts (>12 Months) - South Island Jet Grout Trestles
